Volume II-Problem Area Analysis

Luzerne County Act 167 Phase II

Stormwater Management Plan

June 30, 2010

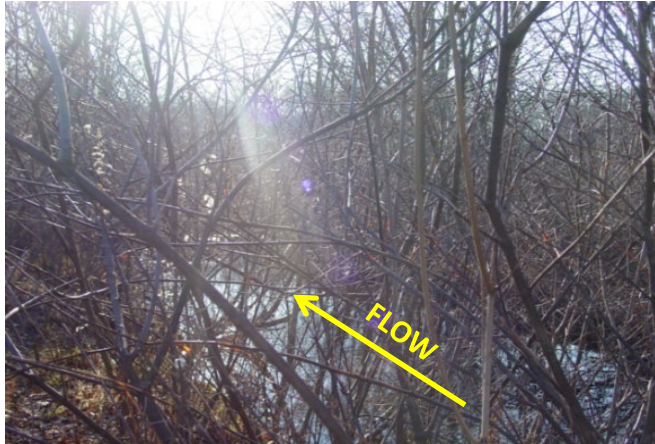
Problem Area - Map ID:	RIC006 & WRI004	Comments
Municipality:	Rice and Wright Township	Flooding was reported by Rice Township and Wright Township at nearby locations. Big Wapwallopen Creek forms the boundary between these townships. According to a local resident, beaver dams in the creek cause significant backwater effects. Homes located at the intersection of Maple Drive and Terrance Drive are the structures most susceptible to flooding from Wapwallopen Creek.
Subwatershed:	Wapwallopen	
Stream name:	Wapwallopen Creek	
Inspected By/Date:	PAK 12/3/2008	
Checked By/Date:	MJW 1/7/10	
Type of Problem (Highlighted):		
1	Flooding	
2	Deficient bridge/culvert	
3	Erosion	
4	Sedimentation	
5	Water/Groundwater Pollution	
6	Other

Description
	Photo of beaver dam resulting in significant obstruction to flow, causing rise in water levels. From discussion with a local homeowner, high water marks are present and can be seen 4 feet above the ground level.

Description
	Photo looking downstream at the beaver dam.

Solution	5.4.1, 5.4.2, 5.6.3, 6.7.1, 6.A
----------	---------------------------------

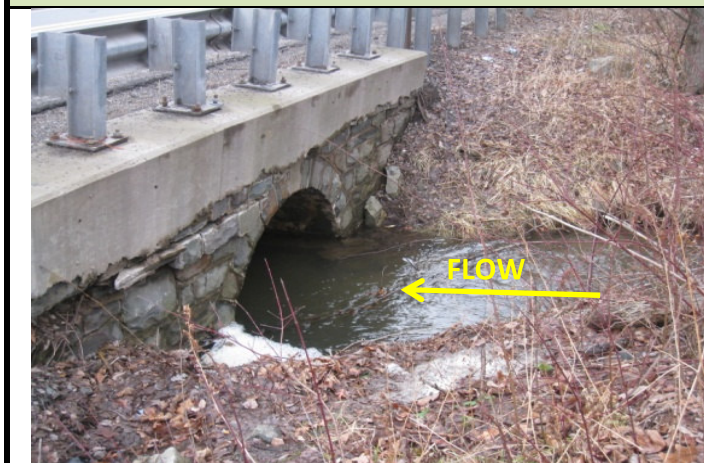
Problem Area - Map ID:	WRI006	<p style="text-align: center;">Comments</p> <p>Flooding problems were reported at this location by Wright Township. The bridge opening appears to be undersized. A steep channel grade is present and bank erosion was observed upstream of the bridge. A sizeable buffer exists along the left bank upstream of the bridge. The right bank, however, has a significantly smaller buffer.</p>
Municipality:	Wright Township	
Subwatershed:	Wapwallopen	
Stream name:	Trib to Wapwallopen Crk	
Inspected By/Date:	PAK 12/3/2008	
Checked By/Date:	MJW 1/7/2010	
Type of Problem (Highlighted):		
1	Flooding	
2	Deficient bridge/culvert	
3	Erosion	
4	Sedimentation	
5	Water/Groundwater Pollution	
6	Other

Upstream face of stone arch bridge. The bridge visually appears undersized. Water elevation from a rain event 10 hours prior to site visit is still relatively high. A large storm would likely overtop the road.

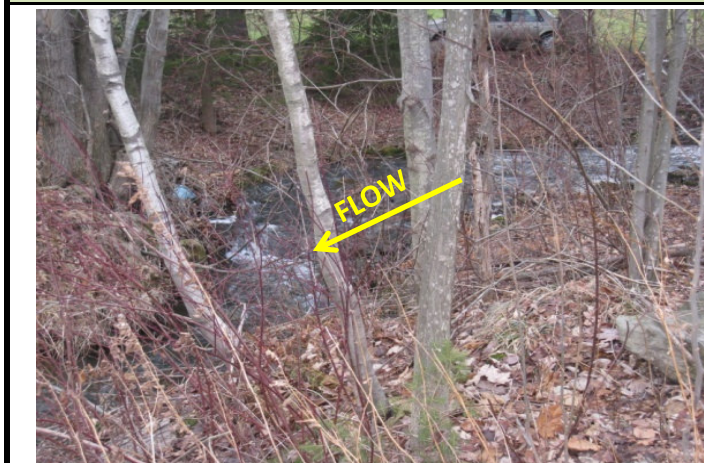
Looking upstream from the bridge. The channel meanders in this section of the stream. Stream is flowing near bank full condition after a relatively minor storm event. The houses located adjacent to the stream could potentially experience flooding during a significant storm event.

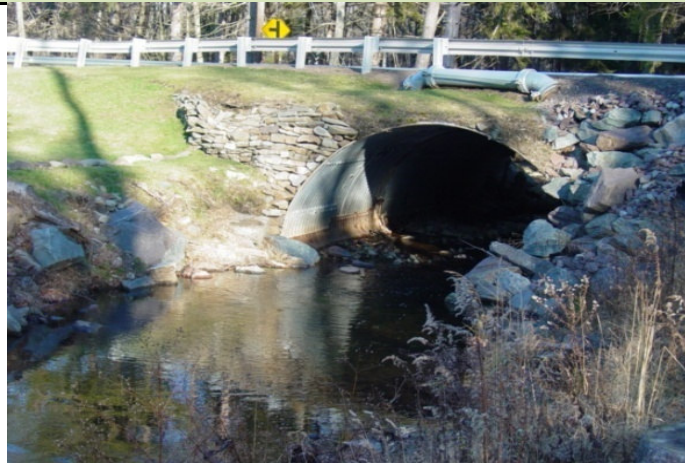
Culvert outlet at WRI009. The hydraulic opening appears to be fairly large and void of debris. The opening looks visibly sufficient to meet the hydraulic requirements of the road.

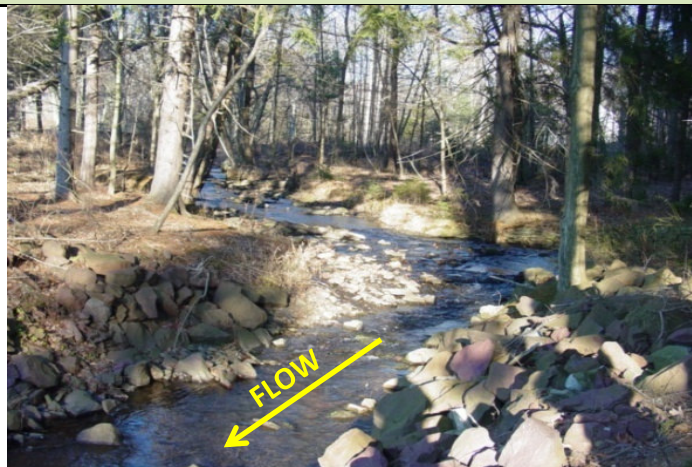
Problem Area - Map ID:	WRI007 & WRI009	<p style="text-align: center;">Comments</p> <p>These problem areas were reported by Wright Township. The culvert for Bow Creek under Main St. over Bow Creek appears to have been recently renovated (WRI009). On the inlet side of the culvert, multiple tree stumps were visible along with new riprap along the banks. Problem WRI007 was located upstream of the culvert. Location is on private property with no trespassing signs so this portion of the stream was not observed.</p>
Municipality:	Wright Township	
Subwatershed:	Wapwallopen	
Stream name:	Trib to Wapwallopen Crk	
Inspected By/Date:	PAK 12/3/2008	
Checked By/Date:	MJW 1/7/2010	
Type of Problem (Highlighted):		
1	Flooding	
2	Deficient bridge/culvert	
3	Erosion	
4	Sedimentation	
5	Water/Groundwater Pollution	
6	Other

Looking upstream towards problem area WRI007 from Main St. The upstream portion of the channel has a well established buffer. Tree stumps with new riprap were visible on the left bank indicating maintenance was conducted in the area.

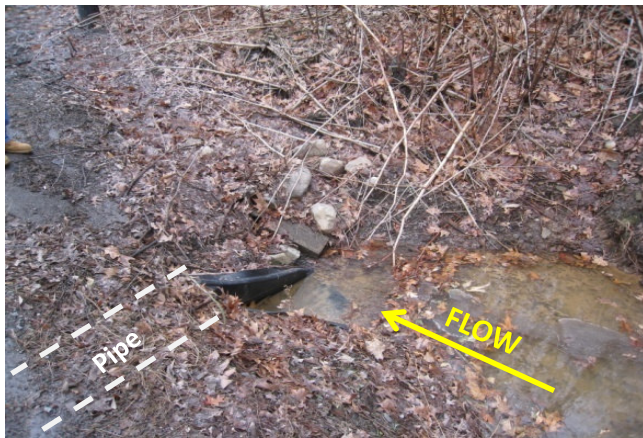
Problem Area - Map ID:	WRI008	Comments
Municipality:	Wright Township	This problem area was reported by Wright Township. The drainage swale from South Main Road discharges to what appears to be an undersized culvert. Water is shown ponded from a rain event which occurred 10 hours earlier.
Subwatershed:	Wapwallopen	
Stream name:	Drainage Swale	
Inspected By/Date:	PAK 2/12/2009	
Checked By/Date:	MJW 1/7/2010	
Type of Problem (Highlighted):		
1	Flooding	
2	Deficient bridge/culvert	
3	Erosion	
4	Sedimentation	
5	Water/Groundwater Pollution	
6	Other

Description
Culvert inlet shown clogged with sediment and debris. No trash rack is provided at inlet to the culvert. Culvert appears relatively new yet may be undersized, thereby increasing sedimentation and debris issues at this location.

Solution	5.6.3, 6.4.8, 6.4.4, 6.B, 6.D
----------	-------------------------------

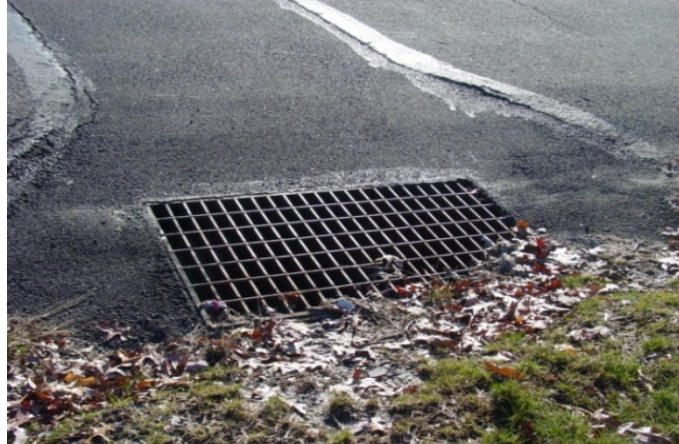
Problem Area - Map ID:	WRI010	Comments
Municipality:	Wright Township	Flooding was reported at this location by Wright Township. No specific cause of the problem could be identified based upon the site visit. No water body was in the vicinity, and the residential area had a storm sewer system.
Subwatershed:	Wapwallopen	
Stream name:	Local Drainage	
Inspected By/Date:	PAK 2/12/2009	
Checked By/Date:	MJW 1/7/2010	
Type of Problem (Highlighted):		
1	Flooding	
2	Deficient bridge/culvert	
3	Erosion	
4	Sedimentation	
5	Water/Groundwater Pollution	
6	Other

</div> <div style="width: 50%; padding-left: 10px;"> <p>Close up of the storm inlet. The road is crowned to direct water to the sides of the road and inlets. No curbing is provided to channel runoff to the inlets.</p> </div> </div>

Solution	5.7.1, 6.4.4, 6.4.5, 6.B
----------	--------------------------

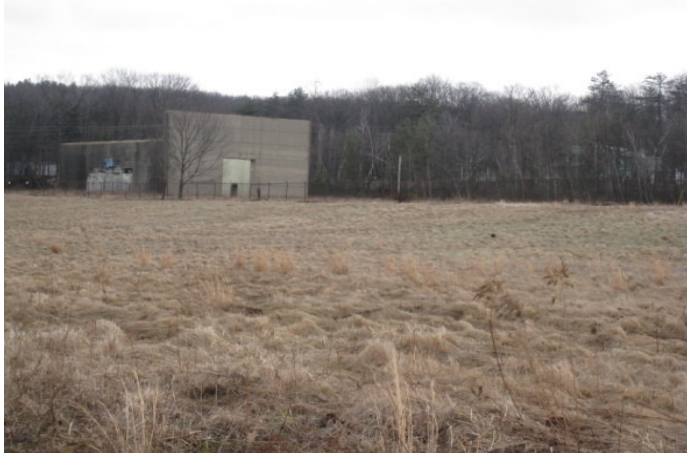
Problem Area - Map ID:	WRI012	Comments
Municipality:	Wright Township	Wright Township reported groundwater contamination at this location. According to the forms provided, groundwater has been contaminated by TCE from an industry in the area. According to a representative of the property owner, DEP is aware of this issue and it is in the process of being resolved.
Subwatershed:	Wapwallopen	
Stream name:	groundwater	
Inspected By/Date:	PAK 2/12/2009	
Checked By/Date:	DEW 1/27/2010	
Type of Problem (Highlighted):		
1	Flooding	
2	Deficient bridge/culvert	
3	Erosion	
4	Sedimentation	
5	Water/Groundwater Pollution	
6	Other

</div> <div style="width: 50%; padding-left: 10px;"> <p>Abandoned building located on the subject property.</p> </div> </div>

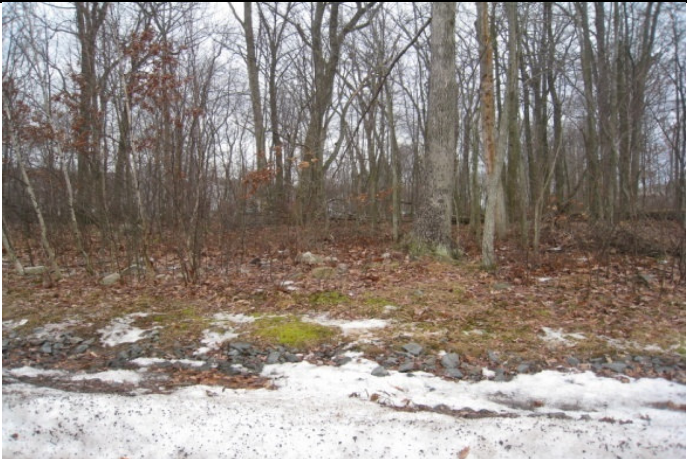
Problem Area - Map ID:	WRI013	Comments
Municipality:	Wright Township	Wright Township reported groundwater contamination at this location. According to the forms provided, groundwater has been contaminated by TCE from an industry in the area.
Subwatershed:	Wapwallopen	
Stream name:	groundwater	
Inspected By/Date:	PAK 2/12/2009	
Checked By/Date:	DEW 1/18/2010	
Type of Problem (Highlighted):		
1	Flooding	
2	Deficient bridge/culvert	
3	Erosion	
4	Sedimentation	
5	Water/Groundwater Pollution	
6	Other

Description
	<p>From end of Brockhollow Road cul-de-sac showing industrial park through trees. It is unclear if this is the area of private residences with TCE contamination. Local newspaper articles report houses located off of S. Church St. have had groundwater contamination, but they are on the other side of the industrial park.</p>

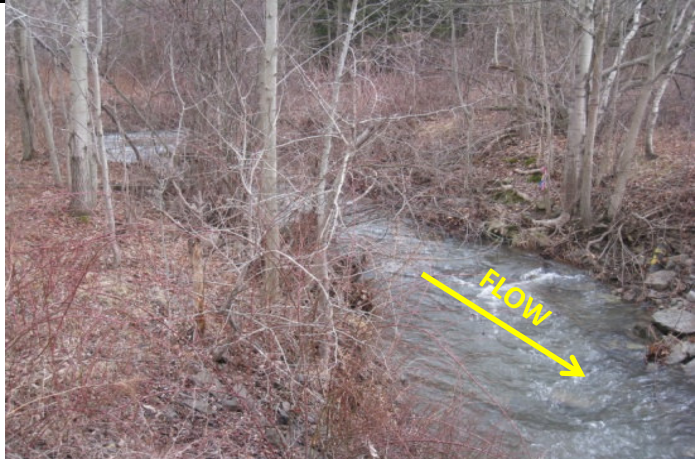
Problem Area - Map ID:	WRI014	Comments
Municipality:	Wright Township	Wright Township reported a previous gasoline spill problem at this location near the intersection of South Main Road and Church Street. Evidence of this problem was not identified during our field observation.
Subwatershed:	Wapwallopen	
Stream name:	Watering Run	
Inspected By/Date:	PAK 2/12/2009	
Checked By/Date:	DEW 1/19/2010	
Type of Problem (Highlighted):		
1	Flooding	
2	Deficient bridge/culvert	
3	Erosion	
4	Sedimentation	
5	Water/Groundwater Pollution	
6	Other

<div style="width: 50%; padding-left: 10px;"> <p>Looking upstream from Church St. bridge adjacent to the gravel parking lot.</p> </div> </div>

Solution	5.4.2, 6.E
----------	------------

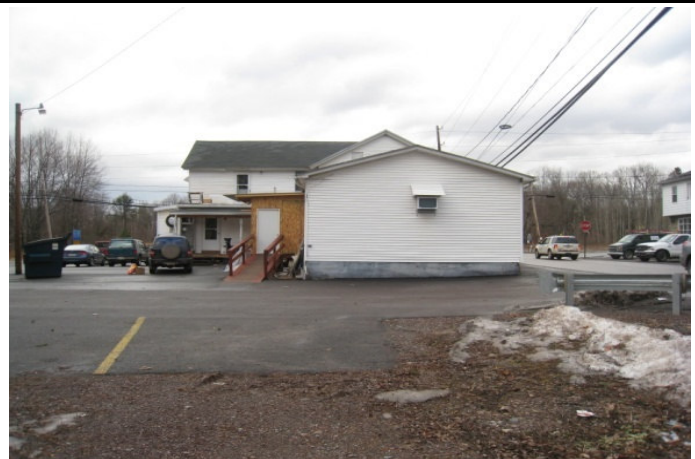
<div style="width: 50%; padding-left: 10px;"> <p>Commercial buildings at the intersection of Church St. and South Main St.</p> </div> </div>
